**GEOLOGY, DESIGN, CONSTRUCTION AND
MAINTENANCE OF VARDØ SUB-SEA
ROAD TUNNEL**

Geologist T.E. Lynneberg	Public Road Administration	Norway
Eng. Geolog. A. Palmstrøm	Ing. A.B. Berdal A/S	Norway
Eng. S.Roska	County Roads Aut., Finnmark	Norway
Eng. K.J. Carstens	Ing. Thor Furuholmen A/S	Norway

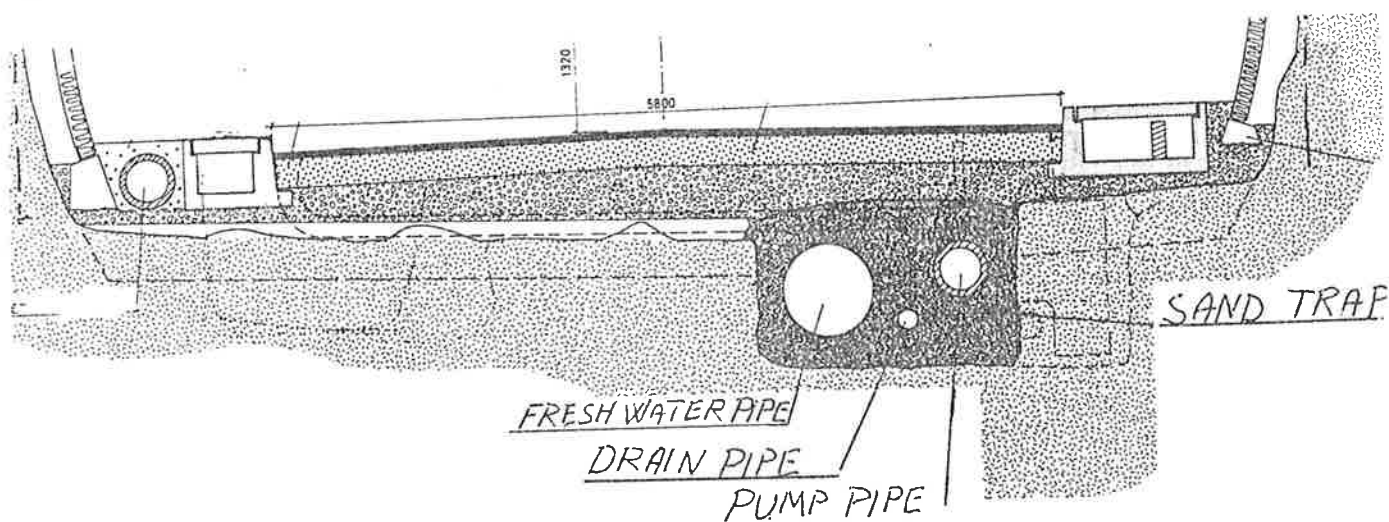
Fig. 8 Drainage ditch with location of the 3 different pipes

The problems consists in an insufficient permeability through parts of the drainage masses together with mud deposits and bacterial growth as well in the drainpipes, as in locally created water pools.

Photo inspections in the drainpipes has shown that the bacterial growth has reduced the cross section with 20 per cent at the most. A cross section of the pipe system is shown on fig. 8.

The mud consists mainly of precipitated products of iron and aluminium oxides, together with the iron bacteria *Leptotrix* and *Gallionella*.

The precipitation of iron and the growth of bacteria are caused by the high level of Fe^{2+} ions in the drainage water. The aluminium hydroxide is deposited aluminium from the aluminium constructions due to corrosion. Great amounts of bacteria similar to *Hyphomicrobium* have also been established in the mud. Growth of *Hyphomicrobium* in seawater has not been reported before.

In order to remove the water pools, extra drains has been put down, and the bacteria removed by high-pressure flushing. It may be necessary to carry through flushing every second year.

In case the remedial actions used so far turn out to be insufficient, the use of chemical remedies must be considered in order to reduce the growth of bacteria.

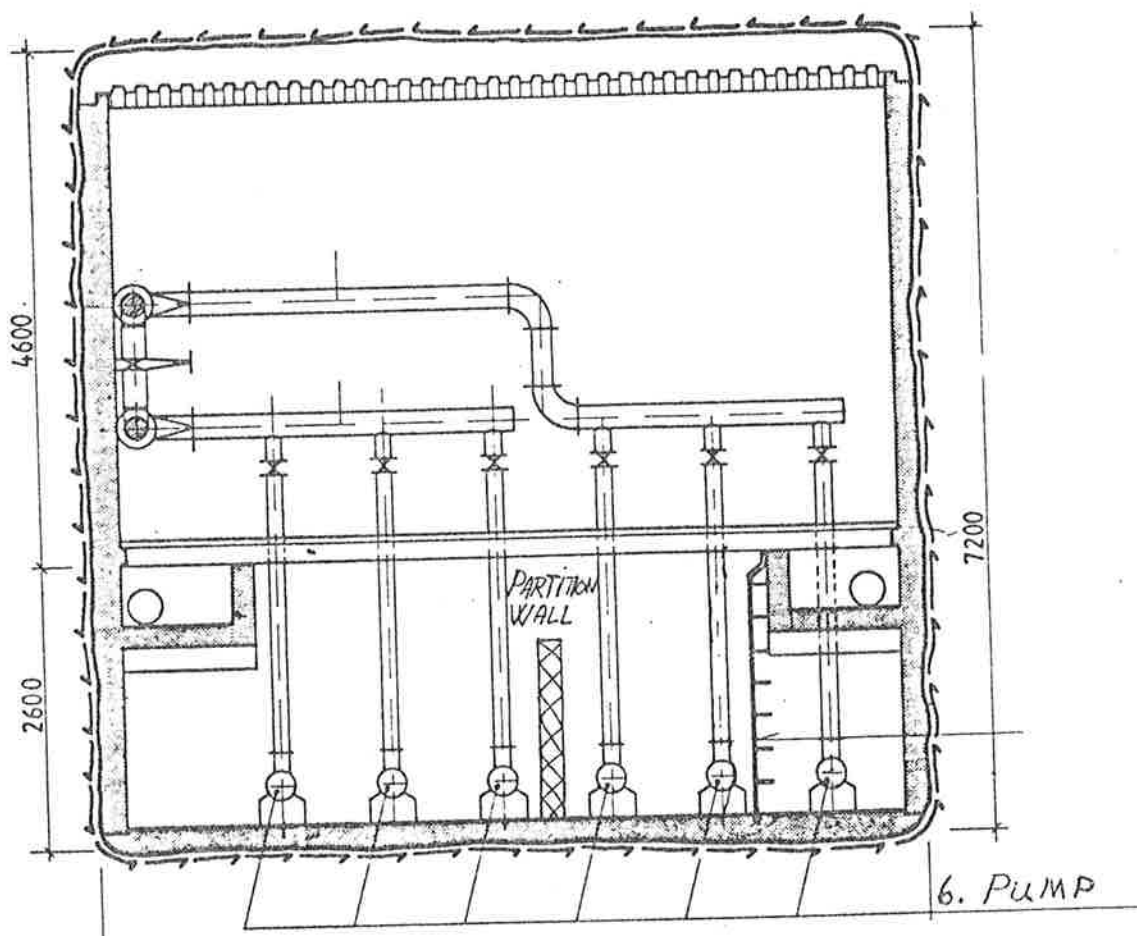
Fig. 9 The pumping station at the low point

However, the pumping station at the low point has caused some trouble.

The pumping station was built with a joint well for both systems (12.3 and 456), fig. 9.

The end of covers of both the manifolds were lateral and the material was too thin. This entailed that one of the manifolds cracked while running. The end covers are now substituted by curved ones with a thicker material.

Five break-downs of the pumps have taken place. Two of these happened due to incorrect assembling. The other three break-downs are probably brought about by a combination of corrosion and particles in the water.

This has entailed that pump repairs have to be done under water. This difficulty has been solved by the installation of a partition wall between the two systems, in such a way that one of the systems can be emptied while the other is in ordinary function.
